Window Site Lines When Foundations Have Settled

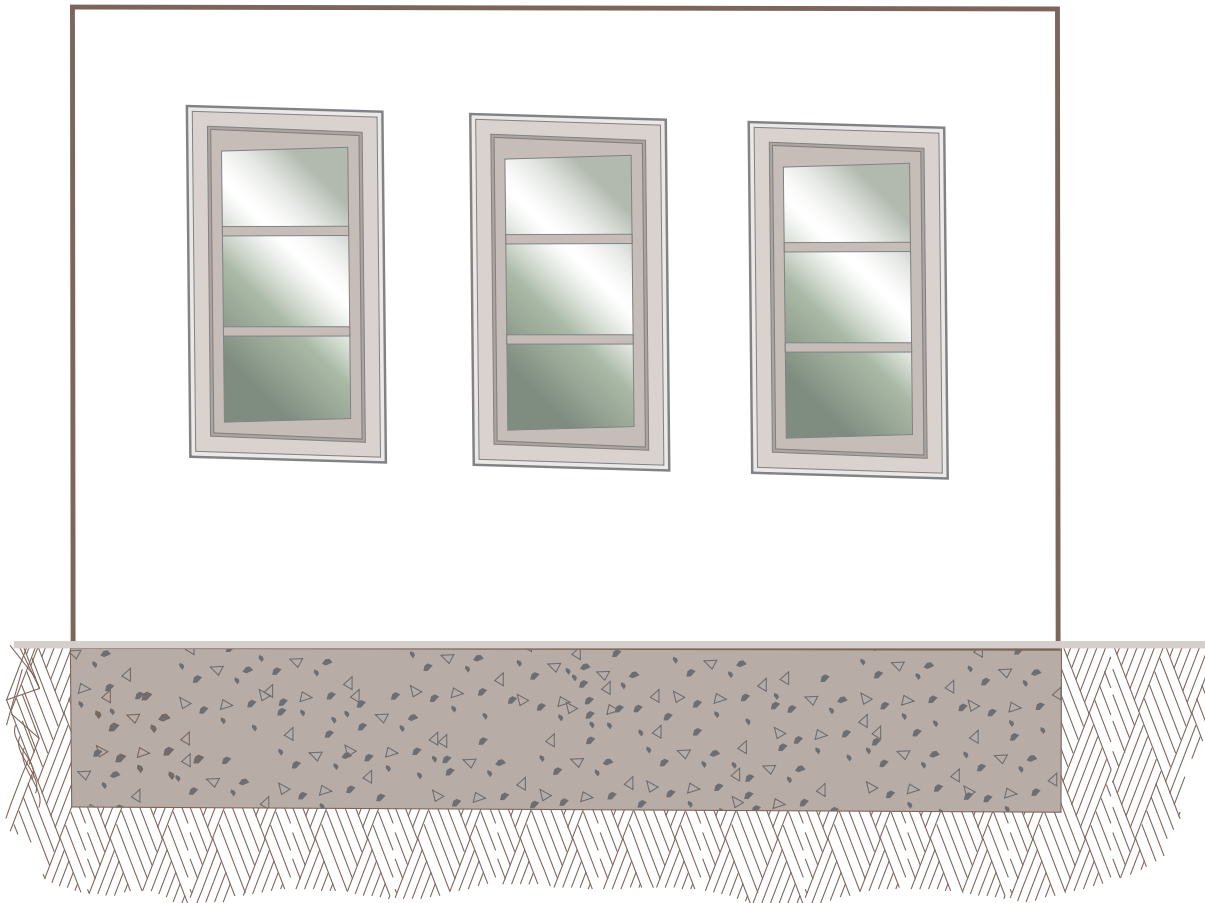
New Windows After Installation

The angled top and bottom rails are visible to the eye. When more than one opening resides on the same wall, this can create a 'stepped' appearance,

as level windows are installed in the non-level openings.

Normally this is a small aesthetic alignment and is barely noticeable but occasionally the stepping visual can be pronounced and obvious. If you're not prepared to level the foundation and make every opening square, you should be prepared for the possibility of stepping and adjust your expectations surrounding the final results accordingly.

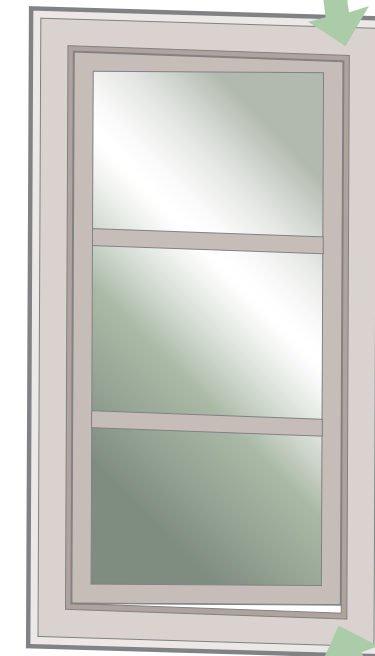
Original Window Before Replacement

Window corner rubs against frame

Gap at bottom of window

When this happens, the window sash openings fall out-of-square and create weather problems when trying to replace old, rotten sash with new—especially when the sash have multiple lite panes typical in older homes.
